Waters Report

SR 3 and Waits Road

Intersection Improvement Project

DES No: 1900138

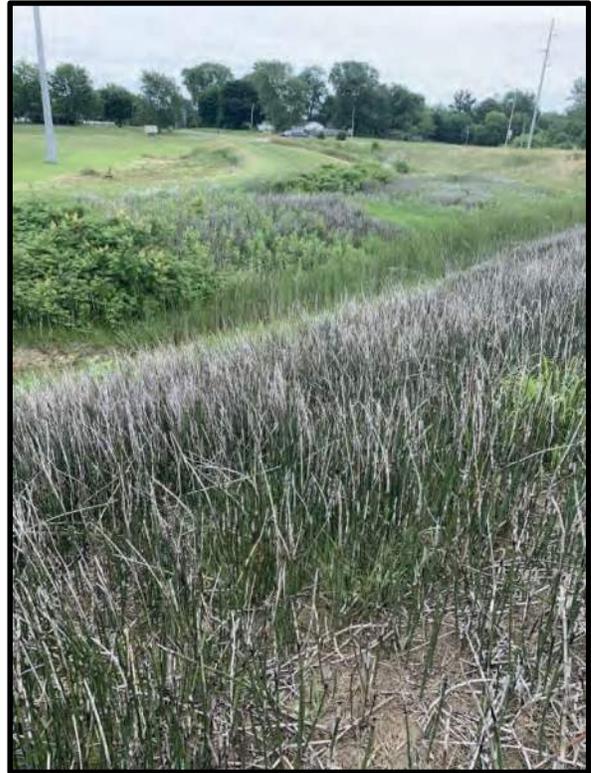
3. View of Wetland A and surrounding terrain, looking southeast. 6/23/2021

2. View of Wetland A and surrounding terrain, looking northwest. 6/23/2021

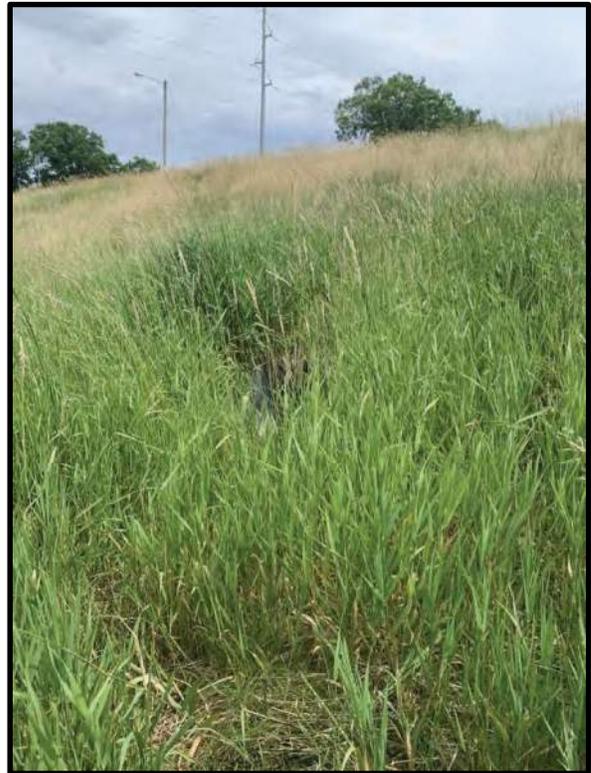
4. View of Wetland A and drainage culvert inlet under Waits Road, looking southeast. 6/23/2021

5. View of Wetland A looking southwest. 6/23/2021

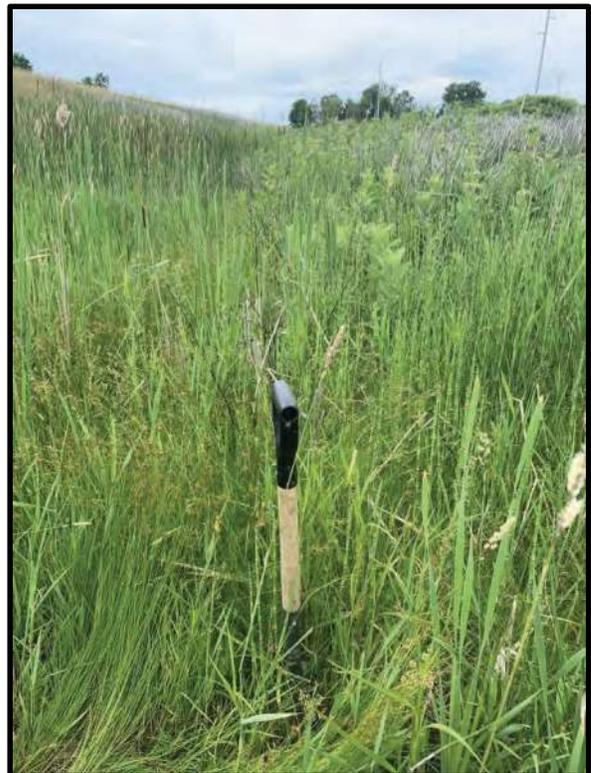
8. View of Wetland A, with shovel located at wetland datapoint A1, looking northwest. A1 passed the dominance test for hydrophytic vegetation. 6/23/2021

9. Wetland data point A1 and close-up of hydric features. 6/23/2021

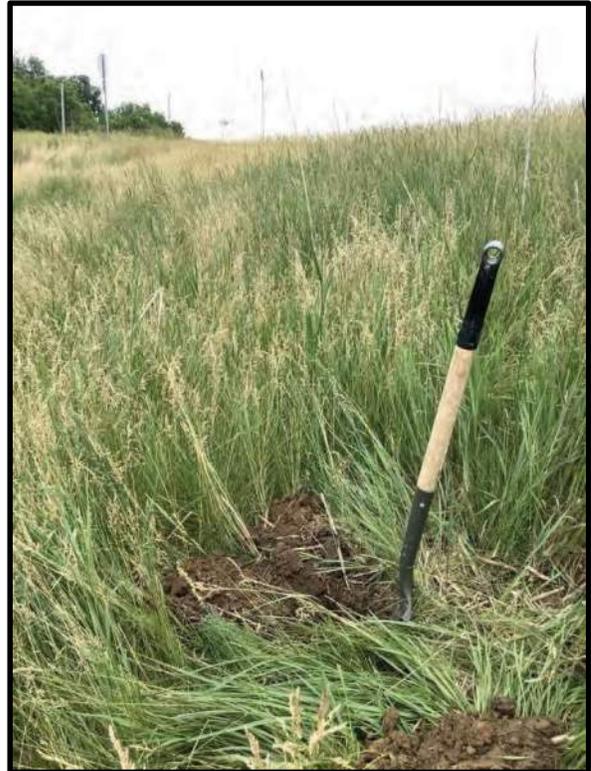
11. View of upland area near upland data point A2, looking southeast. 6/23/2021

10. Upland data point A2. No indicators of hydric soils were present. 6/23/2021

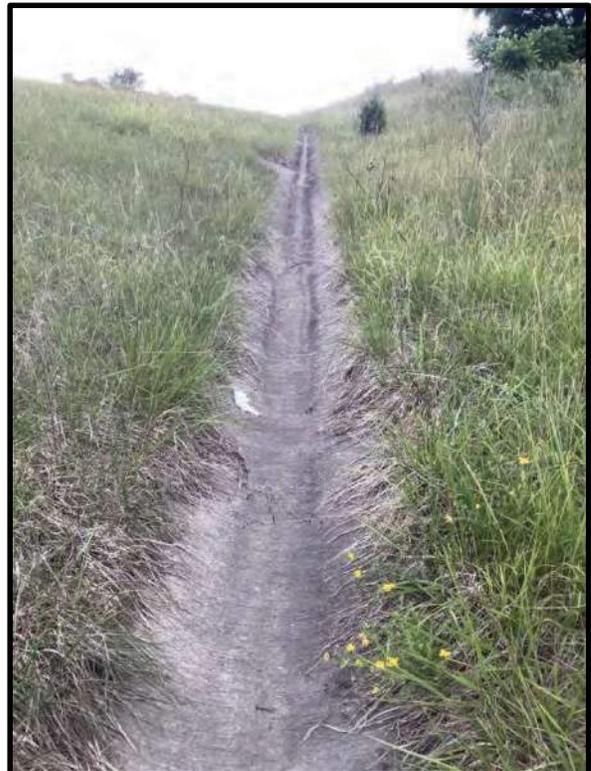
12. View of concrete-lined drainage swale located northeast of SR 3 between Wetland A and Wetland B, looking northwest. 6/23/2021

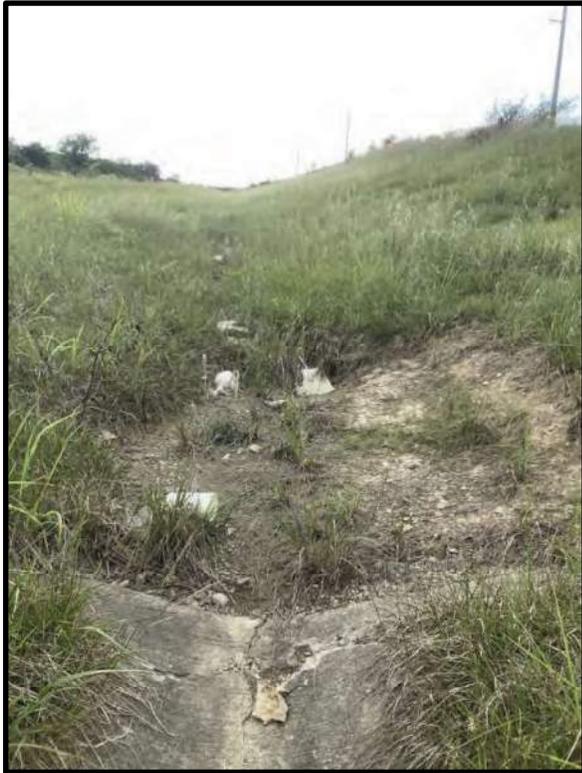
13. View of grass-lined drainage swale transitioning to concrete-lined drainage swale located northeast of SR 3 between Wetland A and Wetland B, looking northwest. 6/23/2021

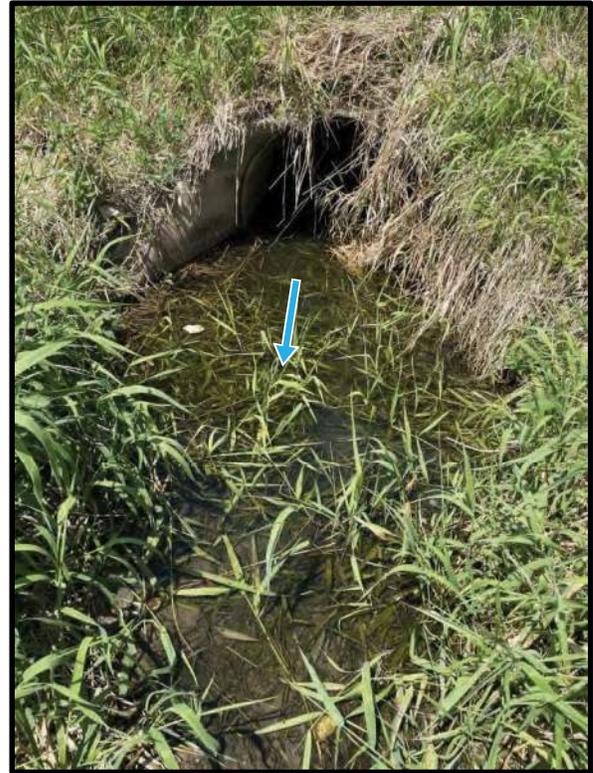
41. View of UNT 3 to Bixler Lake Ditch, abutting Wetland D, looking southeast (downstream). Blue arrow signifies flow direction. 8/4/2021

43. View of UNT 3 to Bixler Lake Ditch and drainage culvert outlet under Waits Road, looking northwest (upstream). 8/4/2021

42. View of UNT 3 to Bixler Lake Ditch from drainage culvert inlet under Waits Road, looking northwest (upstream). The OHWM in this area measured 1.75 feet wide and 4 inches deep. 8/4/2021

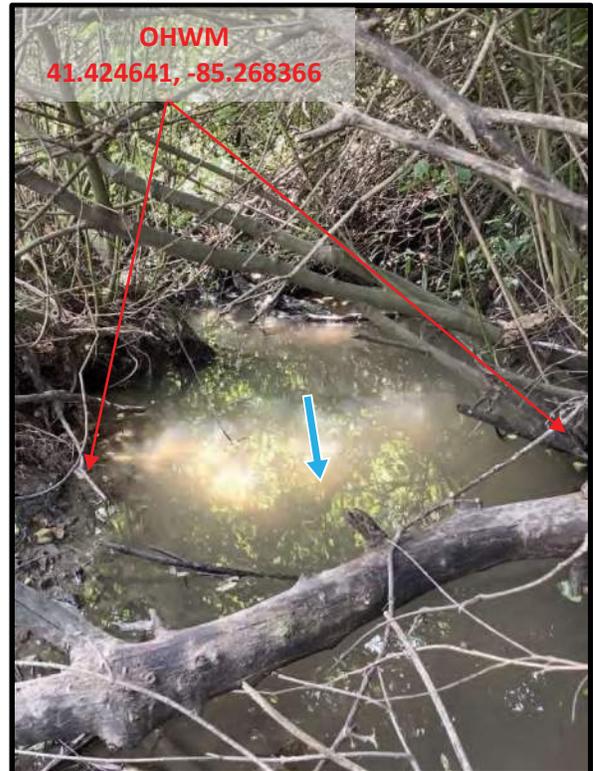
52. View of UNT 2 to Bixler Lake Ditch, west of SR 3, from drainage culvert inlet under SR 3, looking south (upstream). The OHWM in this area measured 3.5 feet wide and 4 inches deep. 8/4/2021

53. View of UNT 2 to Bixler Lake Ditch, west of SR 3, looking north (downstream). 8/4/2021

Within the investigated area, UNT 2 to Bixler Lake Ditch has intermittent flow, and silt and sand substrate. This stream was visually observed on August 6, 2021 to be flowing without any prior rain events within 48 hours; therefore, it was determined to have intermittent flow within the investigated area. The width of the OHWM ranges from 2.2-3.5 feet with an average width of 2.3 feet within the investigated area. The maximum depth of the OHWM is 4 inches within the investigated area. This stream has no riffle/pool complexes within the investigated area.

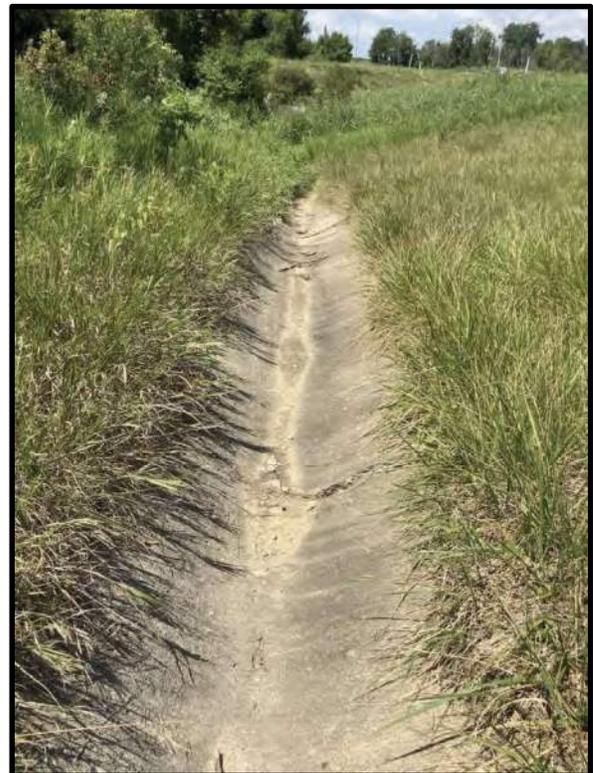
56. View of concrete-lined drainage swale located west of SR 3 between Wetland F and UNT 2 to Bixler Lake Ditch, looking northwest. 8/4/2021

57. View of grass-lined drainage swale transitioning to concrete-lined drainage swale located west of SR 3 between Wetland F and UNT 2 to Bixler Lake Ditch, looking southeast. 8/4/2021

Six (6) drainage swales without an ordinary high water mark (OHWM) were located throughout the investigated area. These drainage swales were mostly vegetated. Minimal surface water, if any, was observed within the drainage swales. A grass-lined and concrete-lined drainage swale located along the east side of SR 3, north of Waits Road drains generally southeast for 462 linear feet within a grass-lined drainage swale and then 133 linear feet within a concrete-lined drainage swale within the investigated area, connecting Wetland B to Wetland C. A grass-lined drainage swale located along the east side of SR 3, north of Waits Road drains generally southeast for 21 linear feet within the investigated area, connecting Wetland C to Wetland B. A grass-lined and concrete-lined drainage swale located along the west side of SR 3, south of Waits Road drains generally north for 35 linear feet within a grass-lined drainage swale, 49 linear feet within a concrete-lined drainage swale, and then 36 linear feet within a grass-lined drainage swale within the investigated area, connecting Wetland F to UNT 2 to Bixler Lake Ditch. A grass-lined drainage swale located along the east side of SR 3, south of Waits Road drains generally north for 122 linear feet within a grass-lined drainage swale within the investigated area, connecting Wetland G to Wetland H. A grass-lined drainage swale located along the east side of SR 3, south of Waits Road drains generally north for 117 linear feet within a grass-lined drainage swale within the investigated area, connecting Wetland H to Wetland I. A sediment-filled, concrete-lined drainage swale located along the south side of Waits Road, east of SR 3 drains generally west for 86 linear feet within a sediment-filled, concrete-lined drainage swale within the investigated area, draining into UNT 1 to Bixler Lake Ditch.

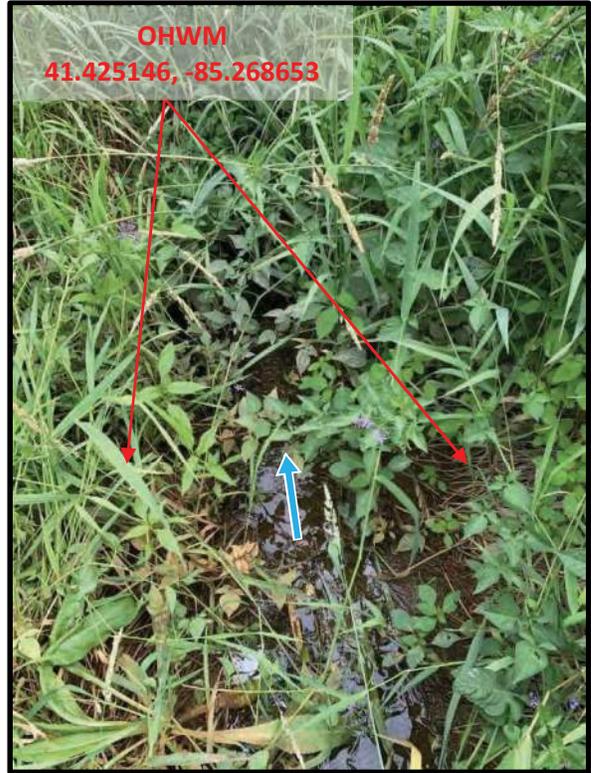
91. View of UNT 1 to Bixler Lake Ditch, looking south (downstream). The OHWM in this area measured 2 feet wide and 2 inches deep. 6/23/2021

Within the investigated area, UNT 1 to Bixler Lake Ditch has ephemeral flow, and silt and sand substrate. This stream was visually observed on June 23, 2021 to have a low flow with a prior rain event occurring within the past 48 hours and the stream was determined to begin at the culvert outlet; therefore, it was determined to have ephemeral flow within the investigated area. The width of the ordinary high water mark (OHWM) ranges from 1-2 feet with an average width of 1.1 feet within the investigated area. The maximum depth of the OHWM is 2 inches within the

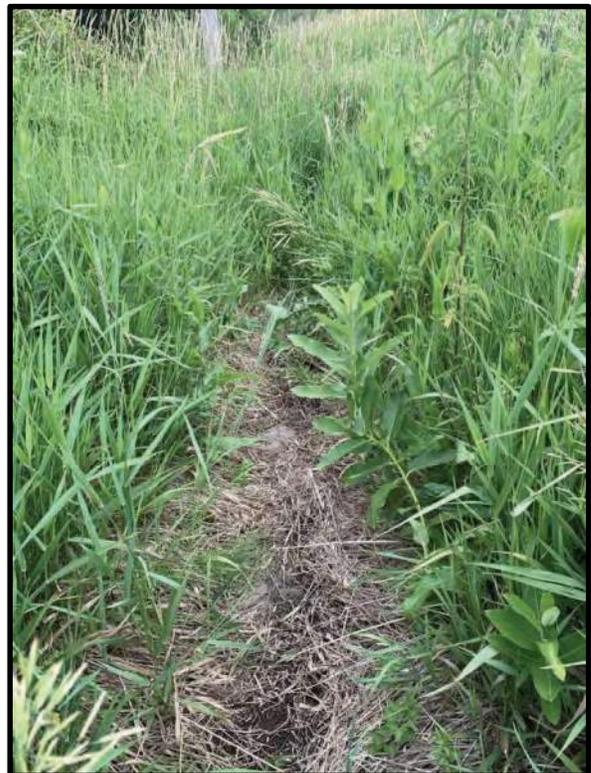
92. View of sediment-filled, concrete-lined drainage swale to UNT 1 to Bixler Lake Ditch, looking west. 6/23/2021
